Hess Lake Aquatic Plant Control Program 2022 Annual Report

A publication of the Hess Lake Improvement Board

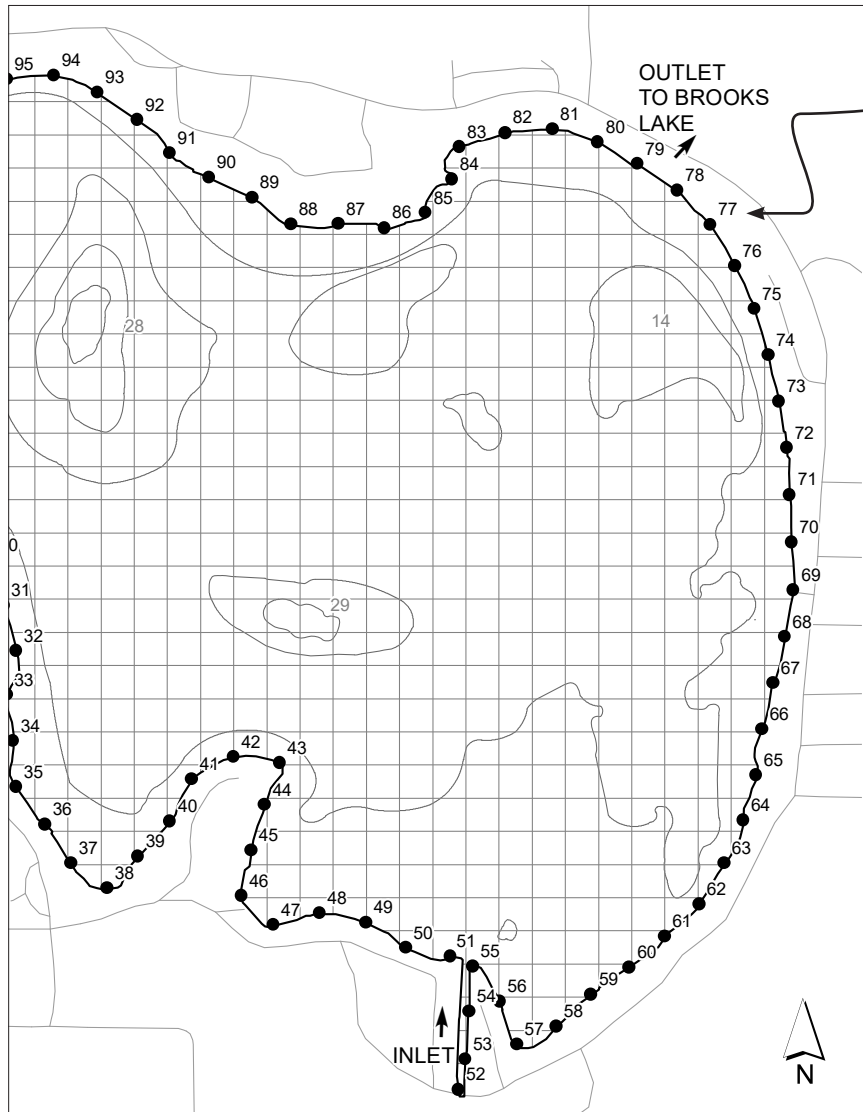
GPS reference points established along the shoreline of Hess Lake are used to guide plant surveys and to accurately identify the location of nuisance plant growth areas.

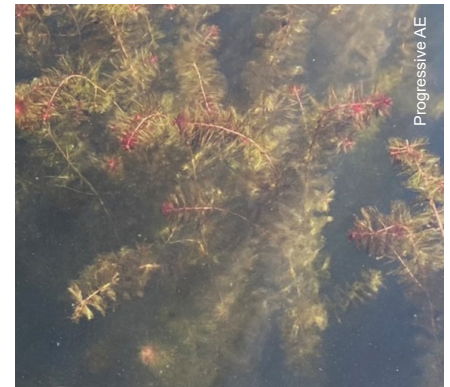
Eurasian milfoil (*Myriophyllum spicatum*)

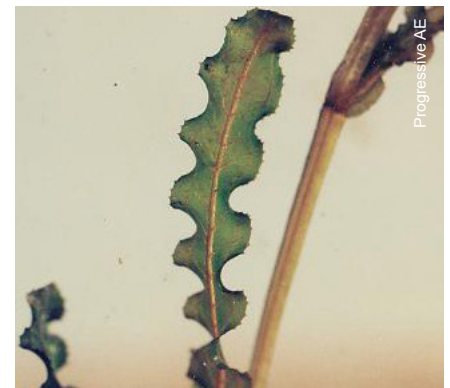
Curly-leaf pondweed (*Potamogeton crispus*)

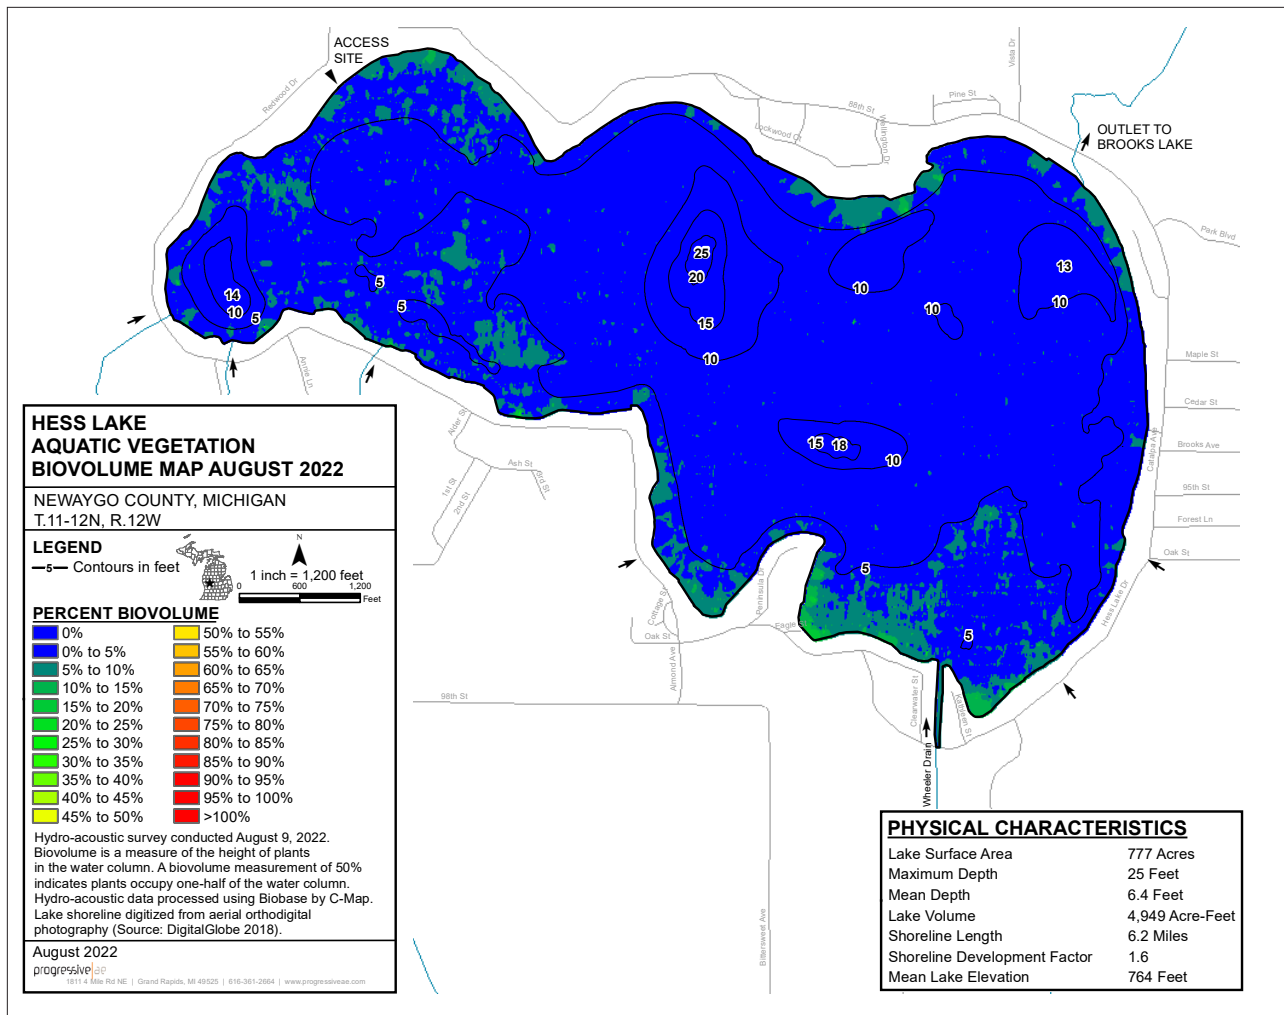
Aquatic Plant Bio-volume

In addition to the survey to determine plant types, hydro-acoustic soundings of the lake were recorded in August of 2022 to measure plant bio-volume (i.e., the height of the plants in the water column). When plants grow to the surface, they occupy 100% of the water column, and those areas would be shown in red on the map. When plants are not present, 0% of the water column contains plants, and those areas are shown in blue. When plants grow half-way to the surface, they occupy 50% of the water column, and are shown in yellow. In Hess Lake, plants were found growing to a depth of about 5 feet or less. The lack of vegetation in Hess Lake is likely related to persistent algal blooms that limit sunlight penetration and rooted plant growth.
