Hess Lake Management Plan

Hess Lake Improvement Board
c/o Newaygo County Drain Commissioner's Office
306 S North Street
PO Box 885
White Cloud, MI 49349

Progressive AE
1811 4 Mile Road, NE
Grand Rapids, MI 49525-2442
616/361-2664

June 2020

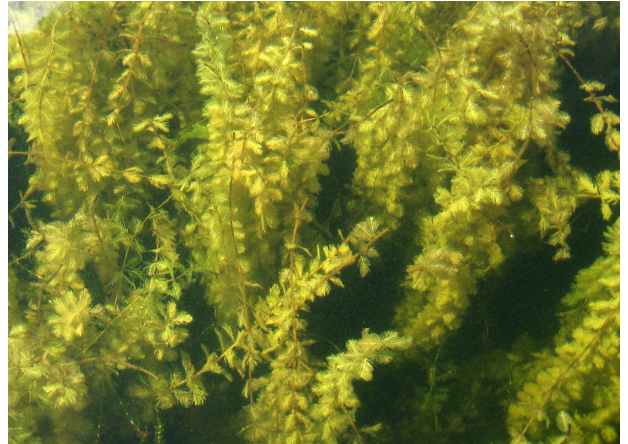
Figure 16. Eurasian milfoil (*Myriophyllum spicatum*).

While most aquatic plants are beneficial, exotic (i.e., non-native) plant species are a problem in many lakes. Exotic aquatic plants often have aggressive and invasive growth. In some lakes, they quickly out-compete native plants and gain dominance. In Michigan, an exotic plant of primary concern is Eurasian milfoil (*Myriophyllum spicatum*, Figure 16). Eurasian milfoil generally becomes established early in the growing season and can spread rapidly by vegetative propagation (i.e., small pieces of the plant break off, take root, and grow). The plant often forms a thick canopy at the lake surface that can degrade fish habitat and seriously hinder recreational activity. Eurasian milfoil infestations have been a problem on Hess Lake for many years.

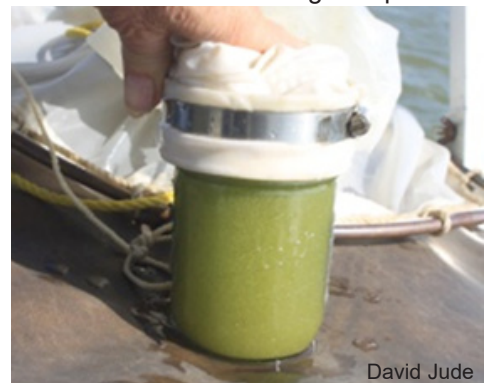
Figure 19. Hess Lake algae.

In the absence of rooted plants, algae has become dominant in Hess Lake, and algae blooms are common (Figure 19). The lake's reduced water clarity favors algae growth: Rooted plants don't receive enough sunlight to stimulate their growth, while algae cells concentrate near the surface where light is plentiful. Algae growth further reduces water clarity and the cycle is perpetuated. Recent studies show blue-green algae, primarily *Microcystis*, is the most common type of algae in Hess Lake (Jude 2020, PhytoTech 2019). Blue-green algae (also called cyanobacteria) are generally considered to be nuisance species due to their tendency to form unsightly floating scums at the lake surface. Another concern with cyanobacteria is the potential to cause harmful algal blooms (HABs) by releasing toxins into the water that, at elevated levels, cause health concerns. A recent analysis of water samples from Hess Lake found a high potential for HABs (PhycoTech 2019).

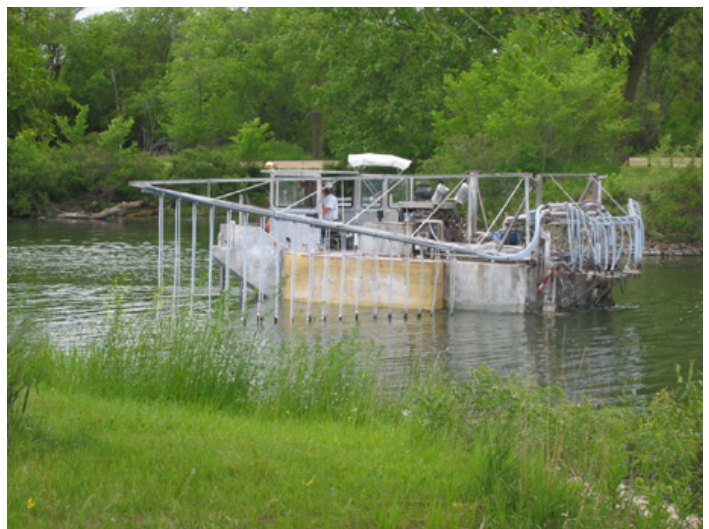
Figure 20. Alum application barge.

Alum is typically applied at a specified dose over a designated portion of the lake with a specialized application barge (Figure 20). In the case of Hess Lake, alum would be applied at a dose of about 8 milligrams per liter over the entire surface of the lake, would likely take about two weeks to complete. Once applied, the alum would strip phosphorus from the water column and settle to the lake bottom. The phosphorus stripped from the water column would remain bound to the alum and become biologically inactive. If applied properly, the alum should not impact lake biota.

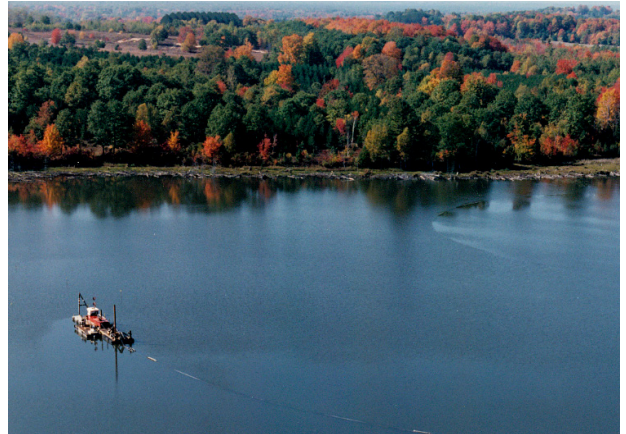
Figure 22. Hydraulic dredge.

Given the shallowness of Hess Lake, dredging to deepen the lake has been discussed frequently over the years (Edmunds Engineering, Inc. 1982, Wade-Trim/Granger 1990, Spicer Group 2010). There are two major dredging methods: mechanical and hydraulic. While both methods involve removing sediment from the water, the operations are quite different. Mechanical dredging involves removing lake sediments with an excavator operating from shore or from a floating barge. Dredged material is disposed on shore or contained on the barge and off-loaded for final disposal. By contrast, material excavated with a hydraulic dredge is pumped in a slurry through a floating pipeline to the point of disposal (Figure 22).

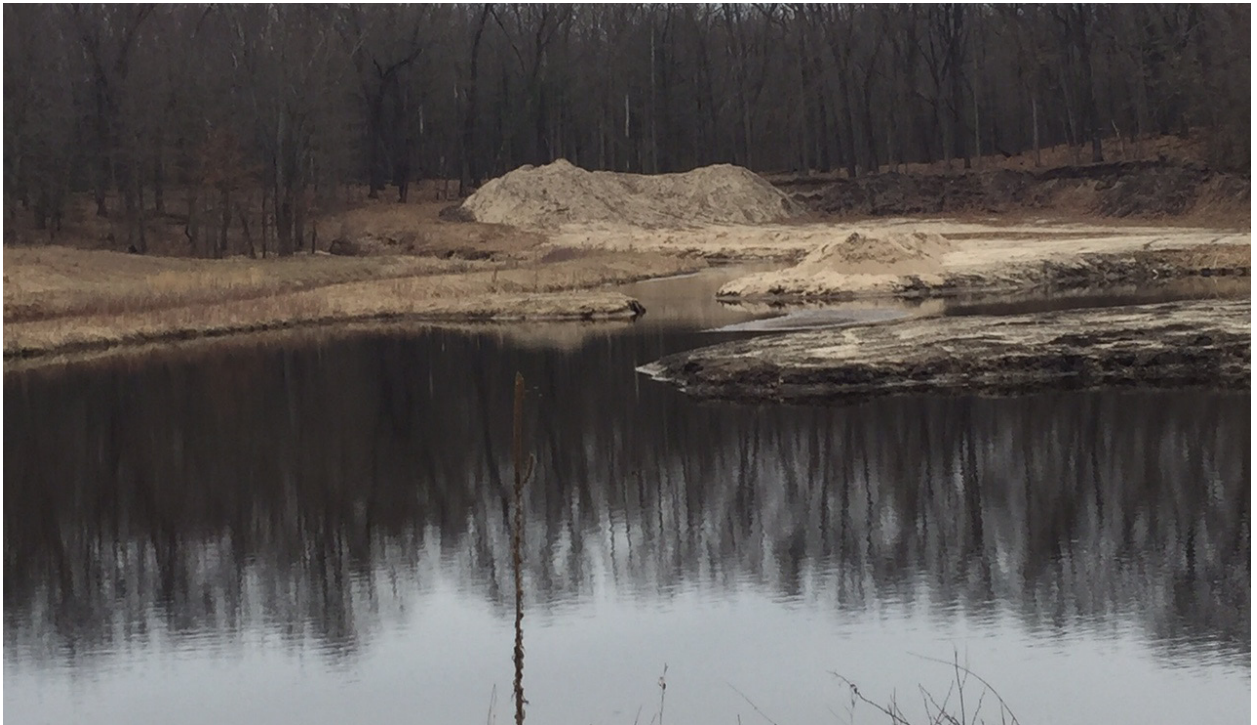
Figure 23. Wheeler Drain sediment basin south of Hess Lake Drive.

In 1986, a sediment basin was constructed on the drain immediately upstream of the lake (Figure 23). In the mid-1990s, additional sediment basins were constructed, check dams were installed, streambanks were stabilized, and a number of conservation practices were implemented all designed to reduce the impact of Wheeler Drain on Hess Lake (FTC&H 1996). Maintenance of existing structural controls on Wheeler Drain is essential to optimizing their effectiveness.

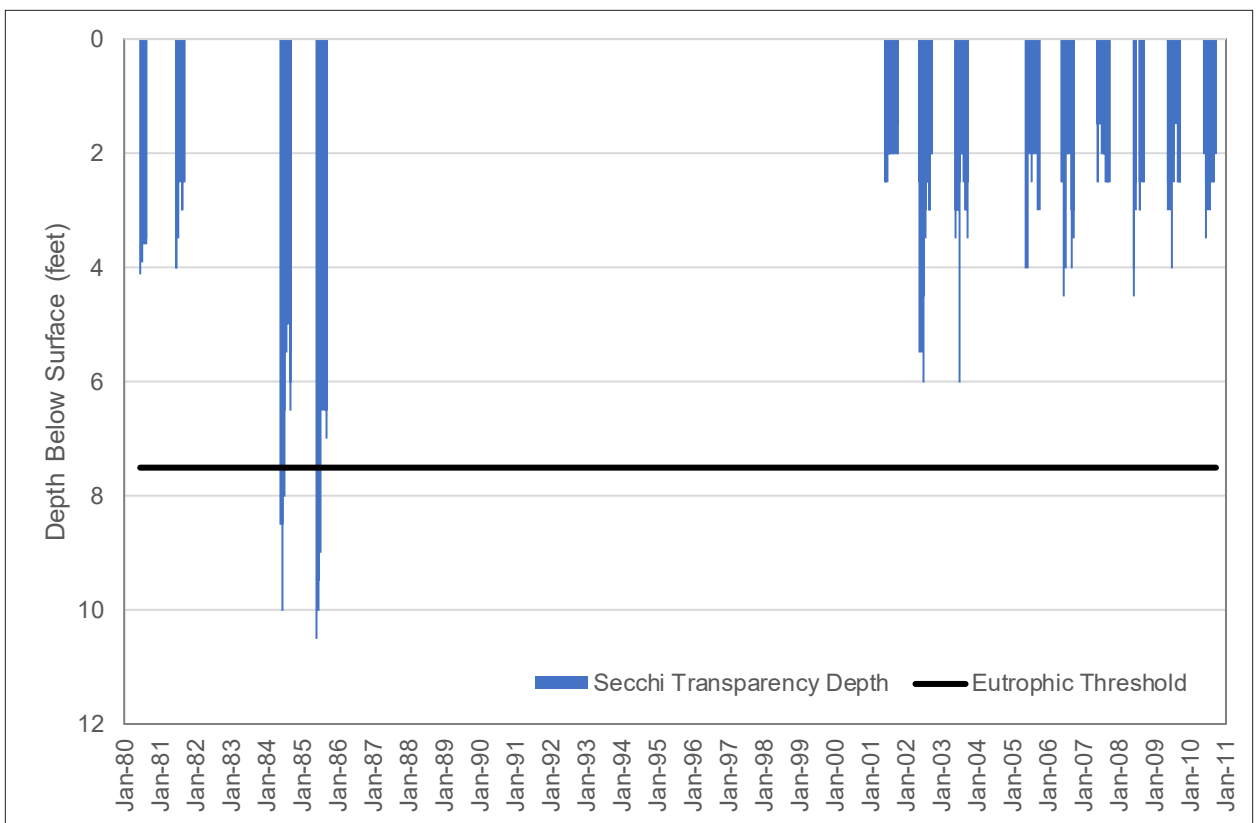
Figure B3. Hess Lake Cooperative Lakes Monitoring Program Secchi transparency, 1980-2010.
